# **INDOOR AIR QUALITY ASSESSMENT**

**Hiram L. Dorman Elementary School  
20 Lydia Street  
Springfield, Massachusetts**

Prepared by:  
Massachusetts Department of Public Health  
Bureau of Environmental Health Assessment  
August, 2002

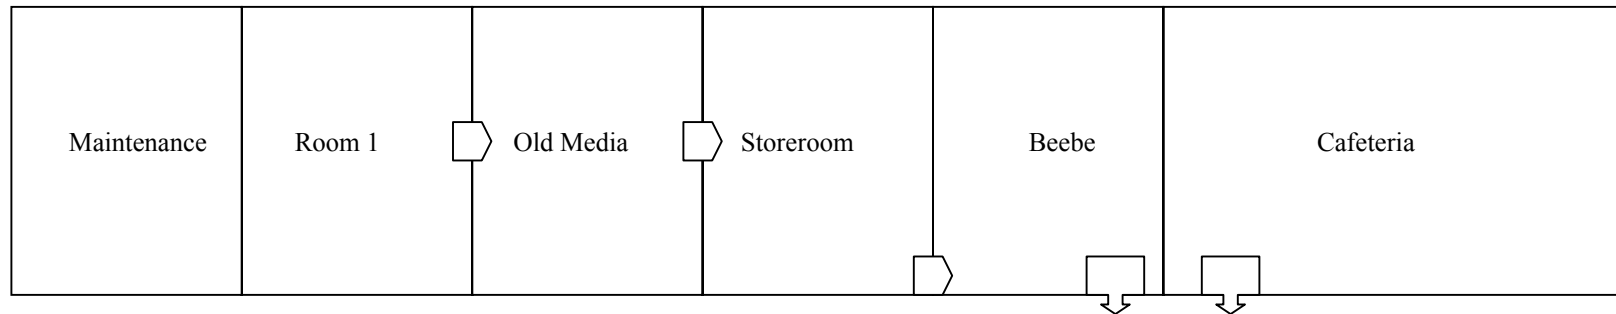
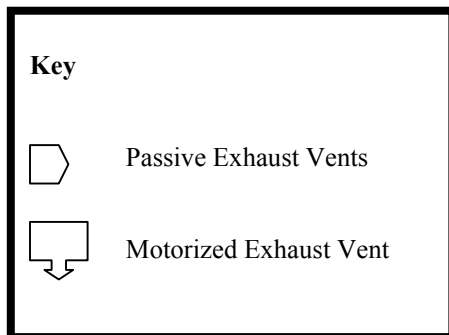
**Figure 2**  
**Diagram of Airflow in South Half of DES Basement**

The basement is divided into rooms on the north and south sides of the central hallway. Rooms on the south side of the basement do not appear to have fresh air supplies. Openings were installed in adjoining walls that serve as passive air vents (see Figures 2 and 3). The exhaust vent (see Picture 7) in the Beebe office provides exhaust ventilation for room 1, the old media center and the storeroom. The passive vent connecting room 1 to the old media center was blocked with paper (see Picture 8). The motorized exhaust vent in the Beebe office was deactivated. Since these rooms do not have openable windows, they do not have any means of providing natural ventilation. The north side of the basement has a univent in the Ross office, with a passive vent serving as the supply for the LaPolice office. If the univent fresh air supply louver is disabled, no fresh air supply exists for these offices. No means for fresh air supply could be identified in the cafeteria nor the teacher's lounge.

8. Remove blockages from passive vents in basement rooms and operate the exhaust fan in the Beebe office during school hours. Operate the univent in the LaPolice office during school hours.

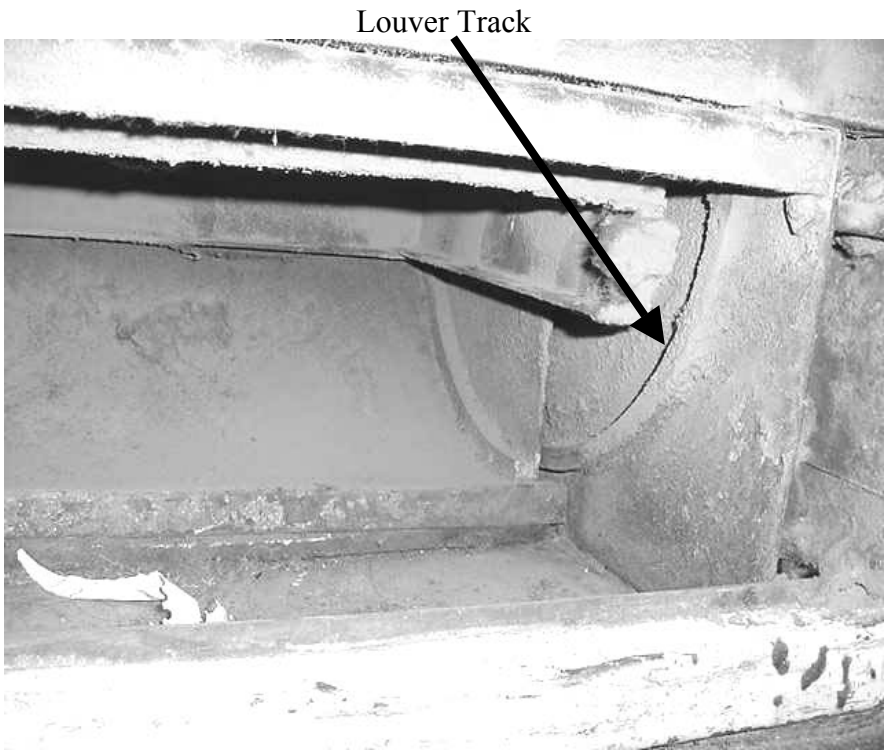
**Picture 2**

The interior of a univent was opened and examined. Airflow into the univent is controlled by a pendulum louver (see Picture 2). The position of the pendulum louver determines the amount of fresh to return air from the classroom. The louver in Picture 2 is fixed in the closed position, preventing fresh air intake by the univent. It also appears that an insulating material is inserted between the bottom of the louver (see Picture 3) and the floor of the univent cabinet, effectively sealing the fresh air intake. Assuming that this univent is representative, the ventilation system is not able to draw fresh air from outdoors. The sole means for introducing fresh air into this building is through open windows.

**Pendulum Track For Louver**

1. Examine each univent for function. Survey classrooms for univent function to ascertain if an adequate air supply exists for each room. Consider consulting a heating, ventilation and air conditioning (HVAC) engineer concerning the restoration of univent fresh air control dampers throughout the school.

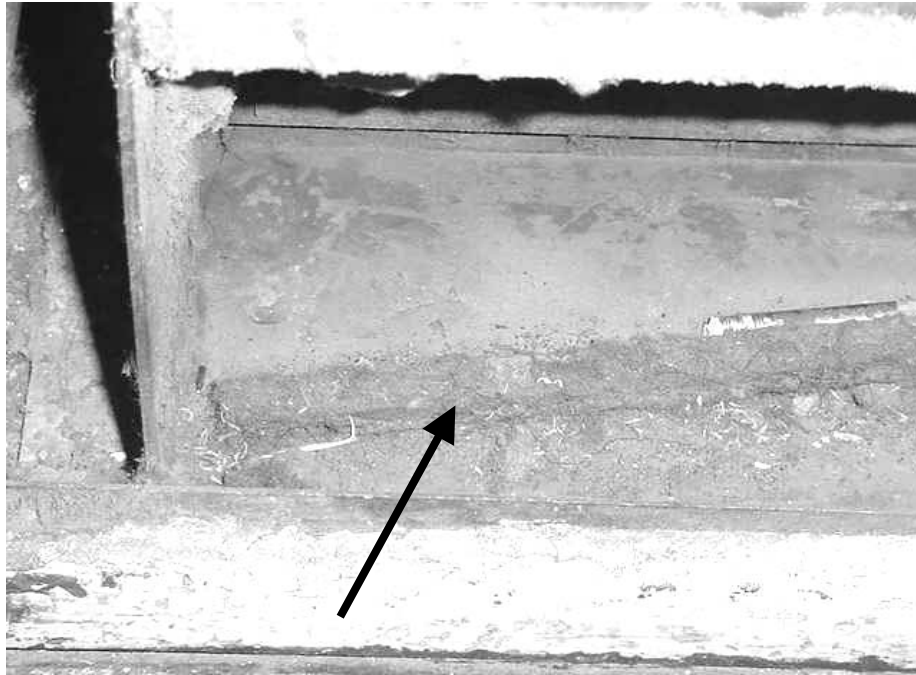
**Picture 3**

**Insulating Material Inserted Between Louver and Cabinet Floor**

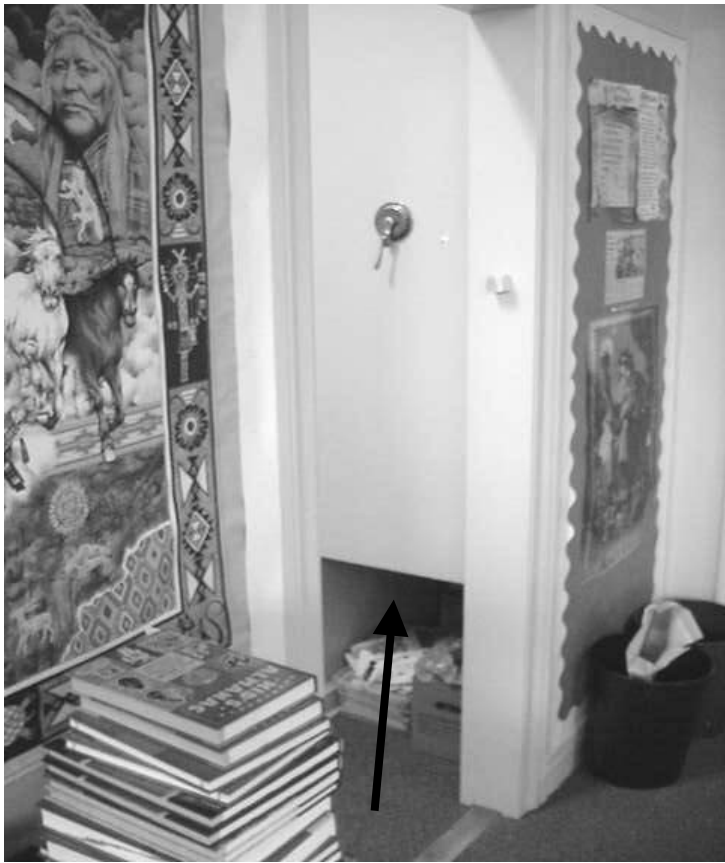
**Picture 4**

An exhaust vent exists in each classroom, consisting of a hearth-like structure located on an interior wall at the floor (see Picture 4). Each exhaust vent is connected to an airshaft that runs from the roof to the basement. Classrooms were constructed around these shafts to provide exhaust ventilation. Pressurization created by the fresh air supply system also provides classroom exhaust ventilation. Airflow into each exhaust vent is controlled by a louver that is connected to a spring-loaded control mechanism (an Atlas Regulator) (see Picture 5). All exhaust vents appear to be set in the closed position, thereby preventing exhaust air from entering the airshafts. The moving of the handle of several Atlas Regulators released plaster, dirt and other debris onto the floor as louvers moved (see Picture 6). The means for draw of air (natural or mechanical) could not be determined since access to the roof could not be gained during this assessment. As with

the univents, the position of exhaust vents would indicate that the exhaust vent system was similarly abandoned at some date prior to this assessment.

**Typical Exhaust Vent**

3. Have an HVAC engineer examine exhaust vents for function and activate if operable.
4. Clean accumulated debris from exhaust vent louvers.
5. To maximize air exchange, the BEHA recommends that the ventilation system operate continuously during periods of school occupancy independent of classroom thermostat control.

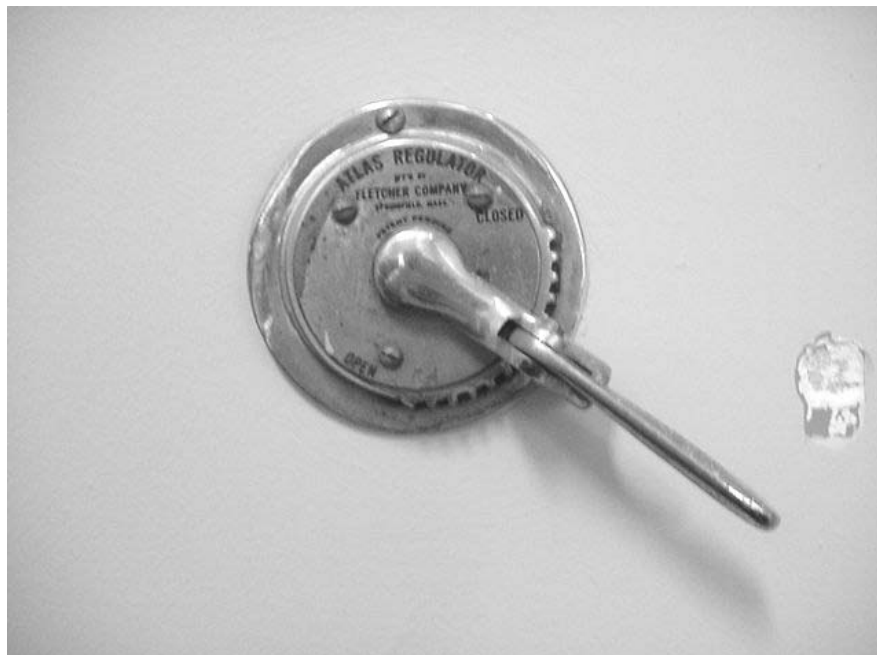
**Picture 5**

**The Atlas Regulator (Exhaust Vent Louver Control)**

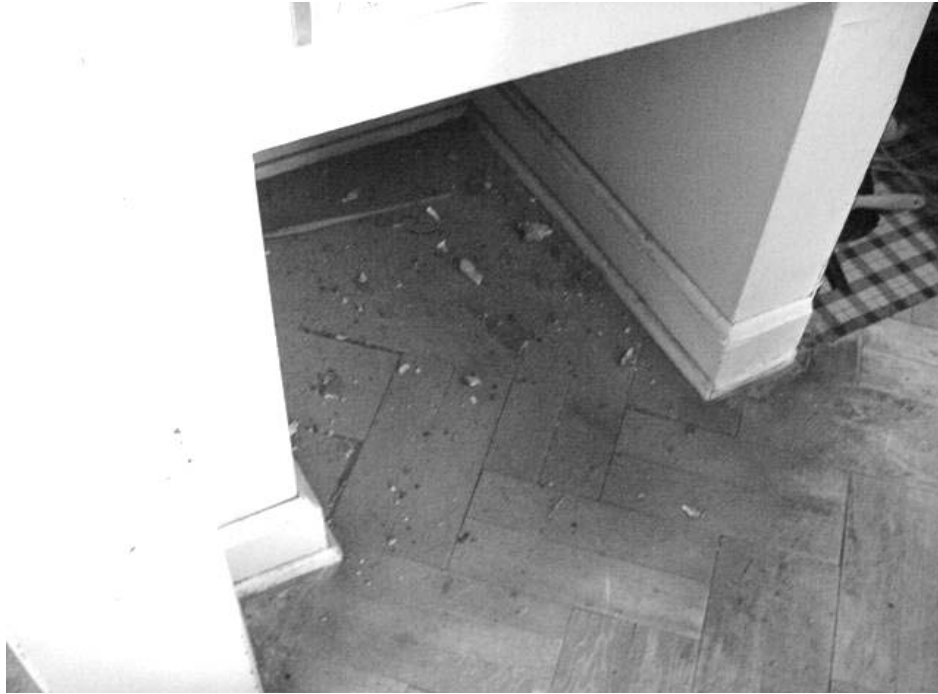
**Picture 6**

**Debris on Floor of Vent After Using the Atlas Regulator to Open the Vent Louvers**

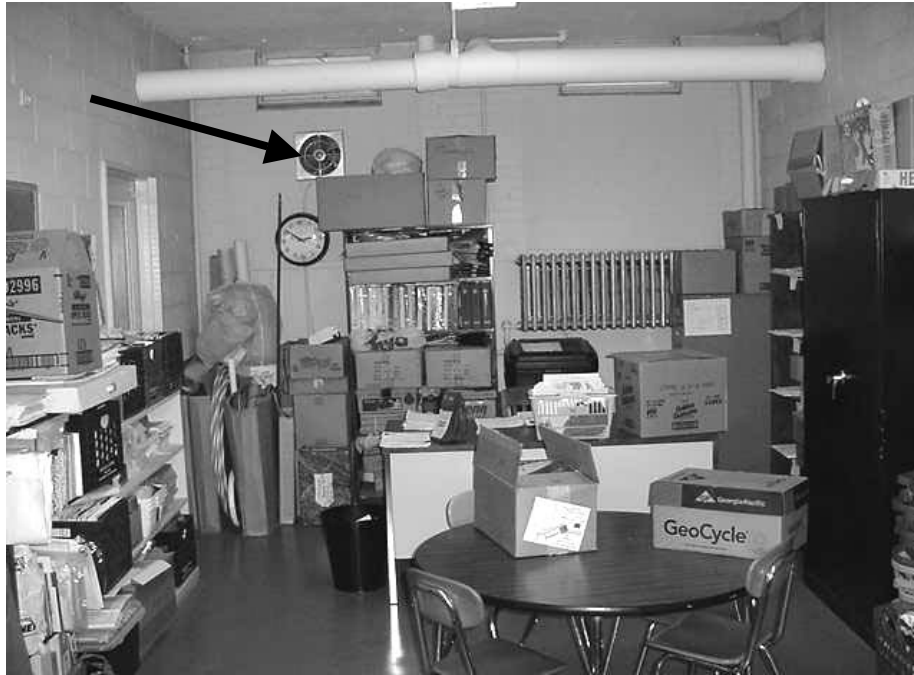
**Picture 7**

**Exhaust Vent in Beebe Office**

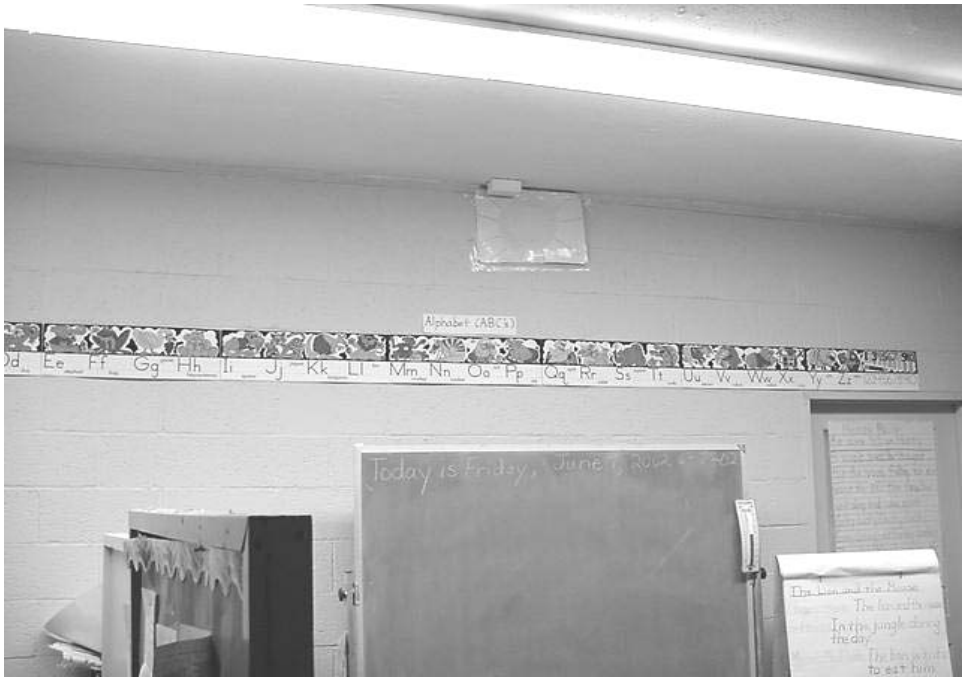
**Picture 8**

**Passive Air Vent Blocked With Paper (Room 1)**

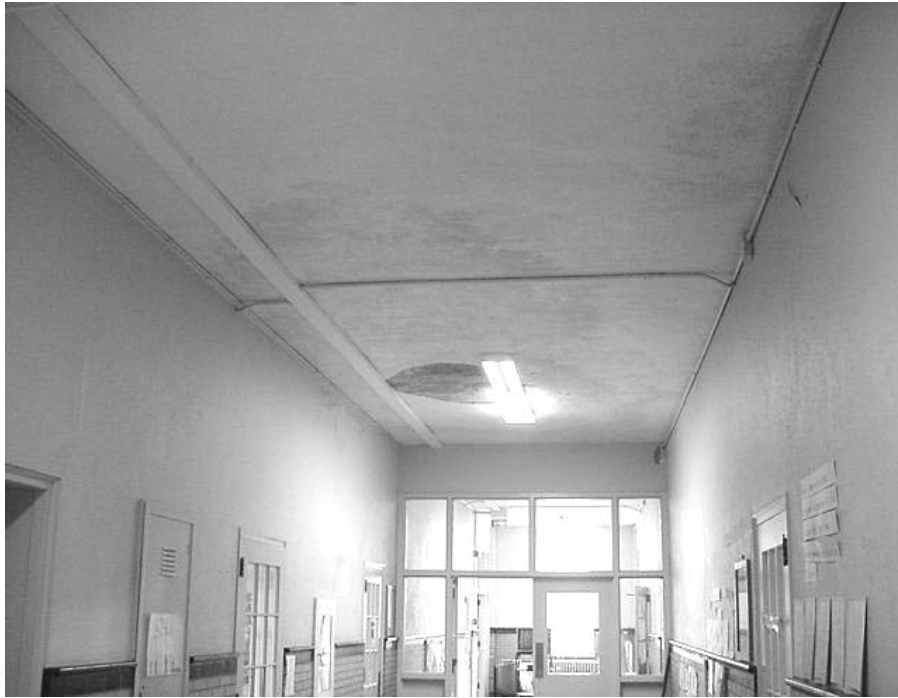
**Picture 9**

Water-damaged ceiling plaster was observed in the second floor hallway and some classrooms (see Picture 9), which indicates a current or historic water penetration problem. Efflorescence (i.e., mineral deposits) was observed on second floor hallway ceilings. Efflorescence is a characteristic sign of water damage to building materials such as brick or plaster, but it is not mold growth. As moisture penetrates and works its way through porous building materials, water-soluble compounds dissolve, creating a solution. As the solution moves to the surface of the material, water evaporates, leaving behind white, powdery mineral deposits. This condition indicates that water from the exterior has penetrated into the building. Water damaged building materials such as wall plaster and ceiling tiles can serve as a medium to support mold growth, especially if wetted repeatedly.

**Water Damaged Plaster in 2<sup>nd</sup> Floor Hallway Ceiling**

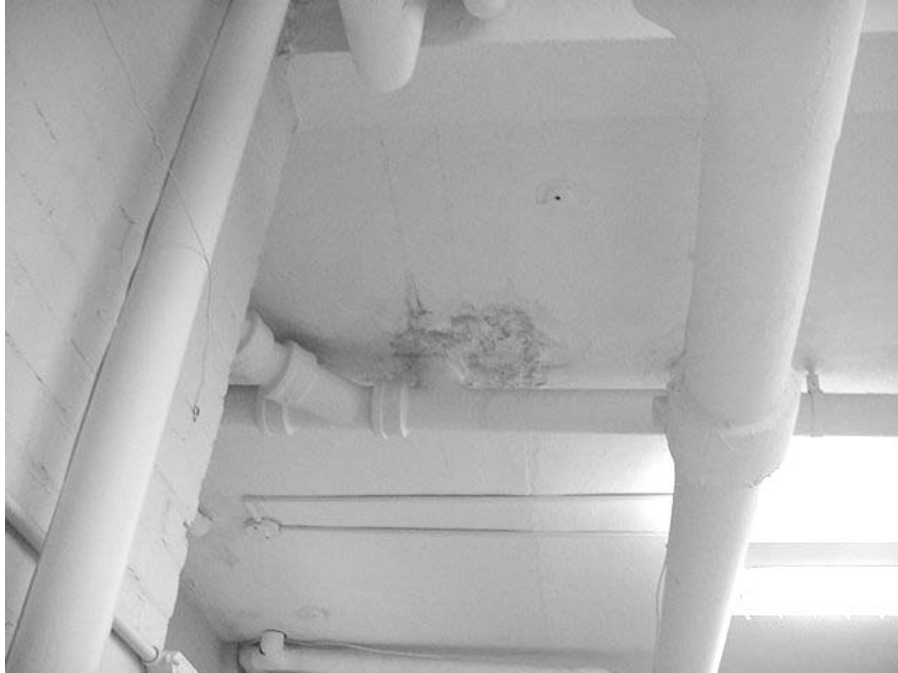
**Picture 10**

Water damage was also noted in the ceiling of the teacher's lounge (see Picture 10), which is attributed to leaks from plumbing/drains from the first floor boy's restroom. Leaks from urinal and toilet drains need to be repaired, cleaned and disinfected. In general, it is recommended that absorbent materials (e.g., gypsum wallboard, carpeting, fabrics, books, cardboard, etc.) be discarded once in contact with sewage (IICRC, 1999). Flooring (such as tile subflooring) should be evaluated, cleaned, disinfected, dried and sealed when appropriate (IICRC, 1999).

**Water Damage Noted In the Ceiling of The Teacher's Lounge**

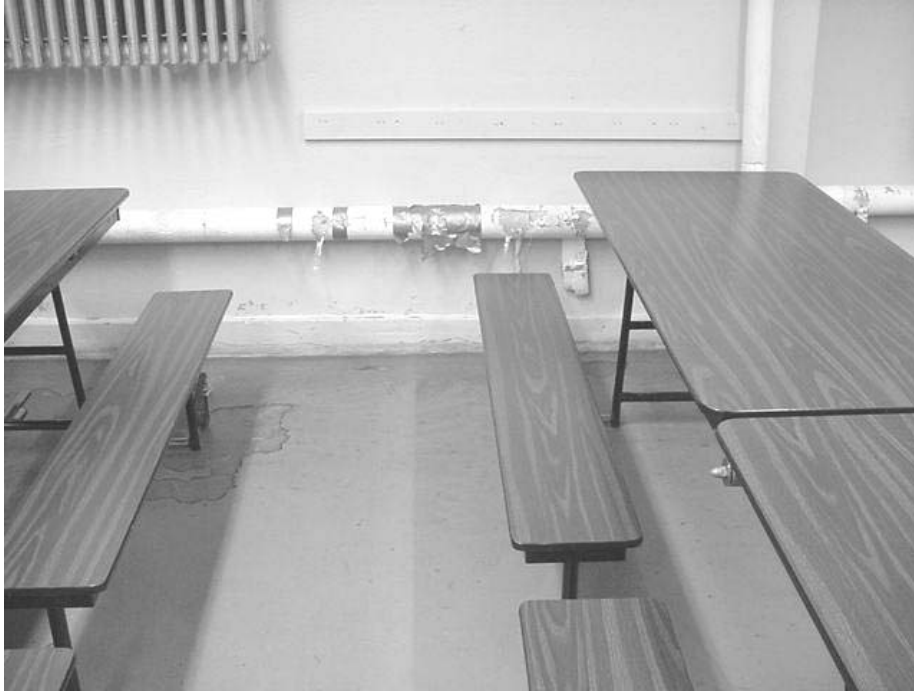
**Picture 11**

Several other conditions were noted during the assessment that can affect indoor air quality. Damaged fiberglass insulation was noted in the cafeteria (see Picture 11). Fiberglass insulation can be a source of skin, eye and respiratory irritation to sensitive individuals. A number of classrooms contained office supplies that contain irritants. Materials such as permanent markers may contain volatile organic compounds (VOCs), which can be irritating to the eyes, nose and throat of sensitive individuals.

**Damaged Fiberglass Insulation In the Cafeteria**

13. Relocate or consider reducing the amount of materials stored in classrooms to allow for more thorough cleaning. Clean items regularly with a wet cloth or sponge to prevent excessive dust build-up.
14. Encapsulate exposed pipe insulation to avoid the aerosolization of fiberglass fibers.
15. Store chemicals and cleaning products properly and out of the reach of students.
16. Consider sealing the abandoned chimney at roof level to prevent rainwater penetration and animal egress.
17. Schedule oil deliveries after school or when school is not occupied. If not feasible, notify school staff including classroom occupants in close proximity to the oil tank, in advance of scheduled delivery. This will avoid fuel odors/vehicle exhaust entrainment into classrooms.
18. Consider relocating parking spaces away from the building to prevent vehicle exhaust from being entrained by open windows.

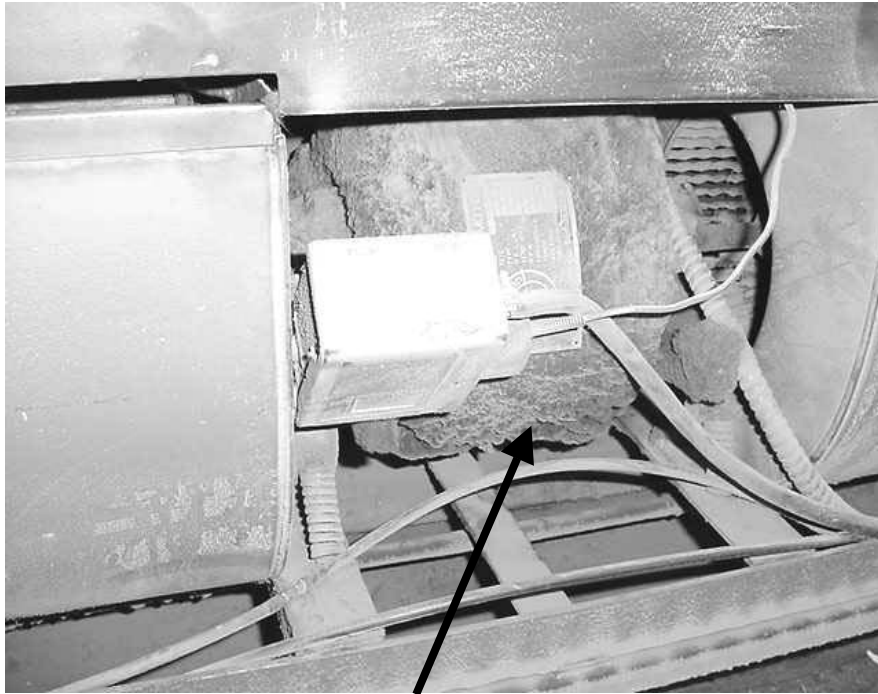
**Picture 12**

A number of univents had accumulated dirt, dust and debris within their air handling chambers, on coils, fans and other components (see Picture 12). These conditions can be attributed to the fact that no means for inserting filters exists in these univents. In order to avoid univents serving as a source of aerosolized particulates, the air handling sections of the univents should be regularly cleaned. However, without filters, dirt, dust and debris can easily collect within the units.

**Accumulated Dust on Univent Motor**

2. Remove all blockages from univents to ensure adequate airflow. Clean out interiors of univents regularly. Have univents examined by an HVAC engineering firm to determine if univents can be fitted for filters.

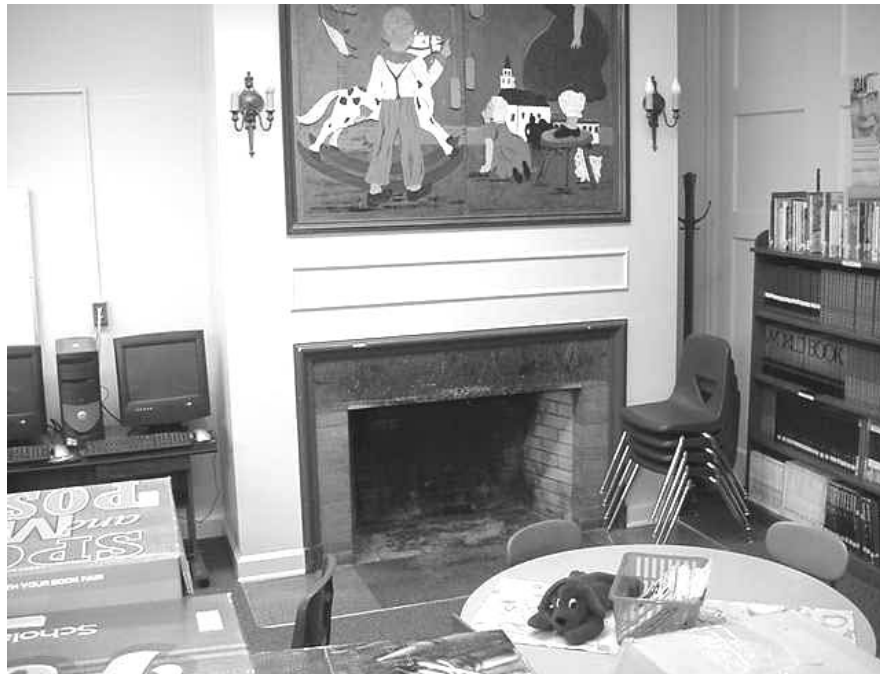
**Picture 13**

A fireplace exists in the media center (see Picture 13) which appeared to be no longer in use. The chimney for the fireplace likely exists on the roof. The top of the

chimney may be open, which can allow rainwater to penetrate down the shaft. In addition, animals/pests may also enter the building through the chimney.

**Fireplace**

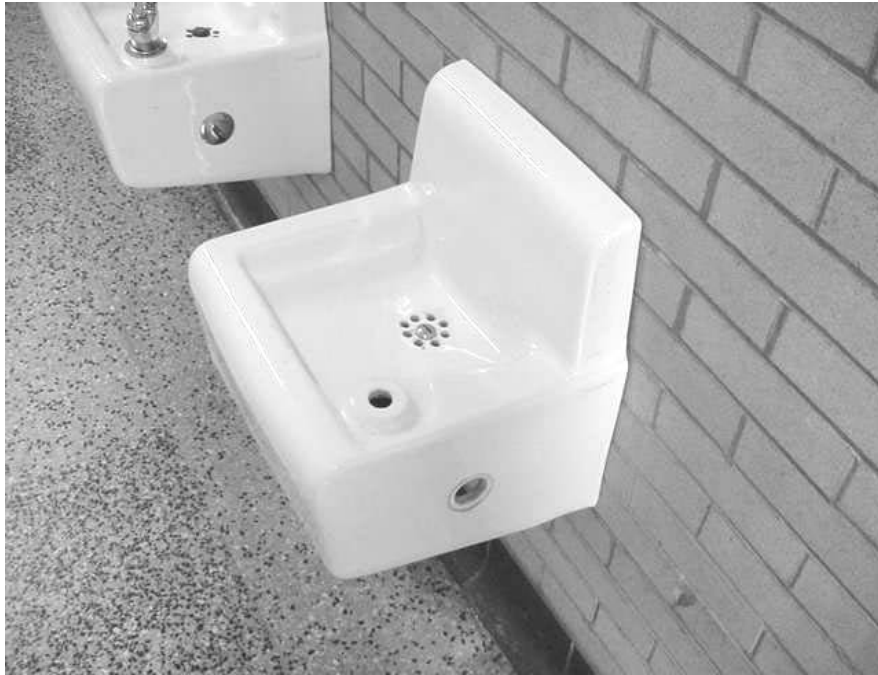
**Picture 14**

An abandoned water bubbler was noted in a hallway (see Picture 14). This bubbler is likely not to have recently drained water, which can lead to dry traps. A trap forms an airtight seal when water is poured down the drain. A dry trap can allow for sewer gas to back up into the building. Sewer gas can be irritating to the eyes, nose and throat.

**Abandoned Water Bubbler**

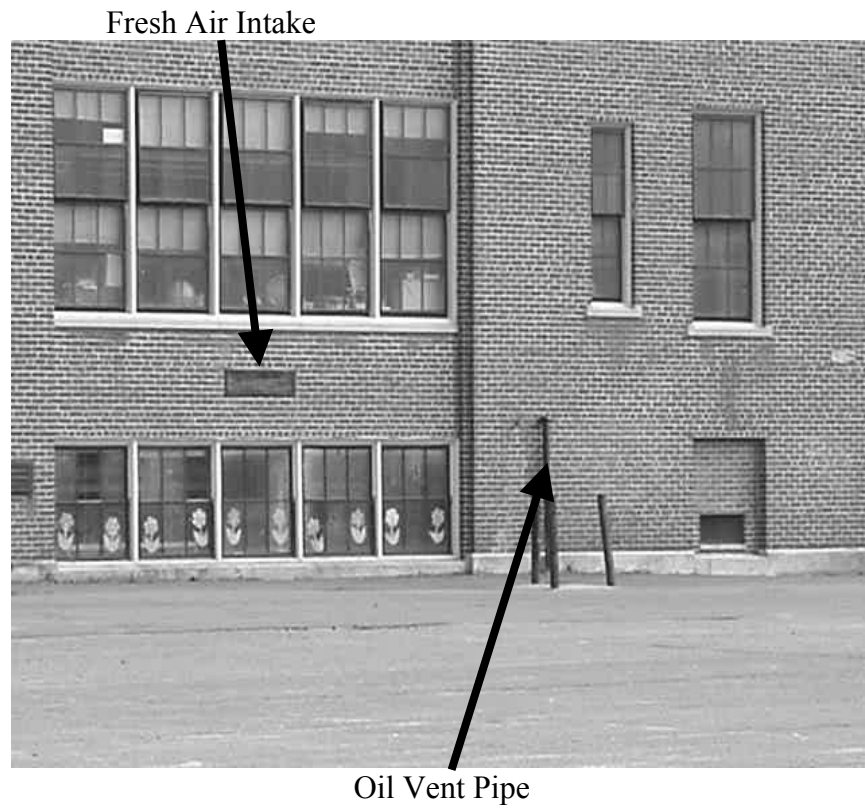
**Picture 15**

Several complaints of vehicle exhaust and fuel oil odors during fuel delivery were reported. The pressure relief vent for the underground storage tank is near the back wall of the building (see Picture 15). Under certain wind conditions, fuel oil vapor may be directed toward the classrooms adjacent to the boiler room roof. Further, cars are parked at the base of the exterior wall near fresh air intakes for the basement classroom and open windows (see Picture 1). Idling vehicles can result in vehicle exhaust infiltration into the building. In turn, this can provide opportunities for exposure to products of combustion, including carbon monoxide. M.G.L. chapter 90 section 16A prohibits the unnecessary operation of the engine of a motor vehicle for a foreseeable time in excess of five minutes (MGL, 1986).

**Oil Tank Relief Valve, Note Height In Relation To Window and Univent Fresh Air Intake**
